Commercial Building Inspection

918 Sierra Drive

Modesto, CA

December 8, 2010

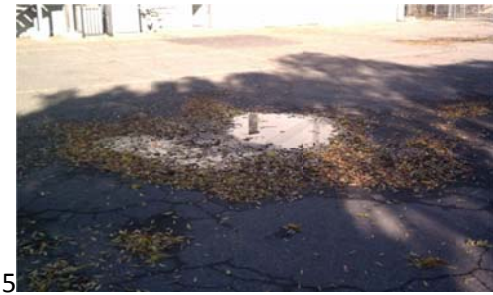
5

- Parking lot on the south side of building is in very poor condition. (Picture 5)
- Parking lot does not appear to have been sealed in a very long time, causing water damage each time it rains.
- Excessive cracking was observed the northwest of the single area drain.
- Standing water was observed in multiple locations, indicating insufficient drainage to the area drain.
- Standing water was observed in the area drain, indicating drywell could be at capacity or not percolating.
- Signs of insufficient or plugged drainage at the bottom of the ramp access on the west side of the building (Pictures 6 and 7). This is causing water to migrate into the building.

- Re-grade and re-pave parking lot.
- Seal the parking lot every 3-5 years to prevent premature wear.
- Address area drain issue by re-drilling the drywell or tying into city storm drain.
- Repair drainage at the bottom of the ramp.

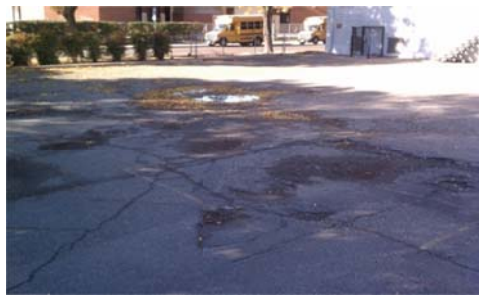
8

- Parking lot striping and signage was non-existent. (Picture 8)
- It appears the parking lot was striped at one point but has since faded.

- After sealing the parking lot, re-stripe.
- Consider installing handicap stalls and the associated signage should it be required by the governing jurisdictions.

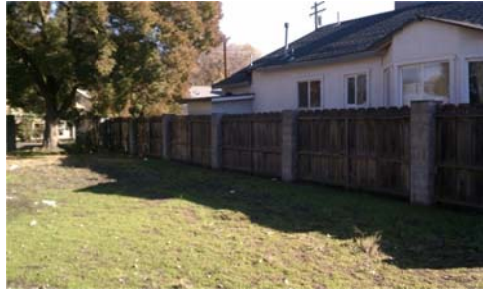
9

- Chain-link fencing along the east and west side of the property is in good condition.
- Wood fencing spanning between masonry piers on the south side of the property is in various states of disrepair. (Pictures 8-10)
- Many dogs were freely moving between neighboring property and the alley and the inspected property during each site visit.

- The inspector strongly recommends re-building southern fence, specifically for the safety of those who will use the inspected property upon purchase.
- Masonry piers are in good condition and can be used as the primary support for the re-built fence.

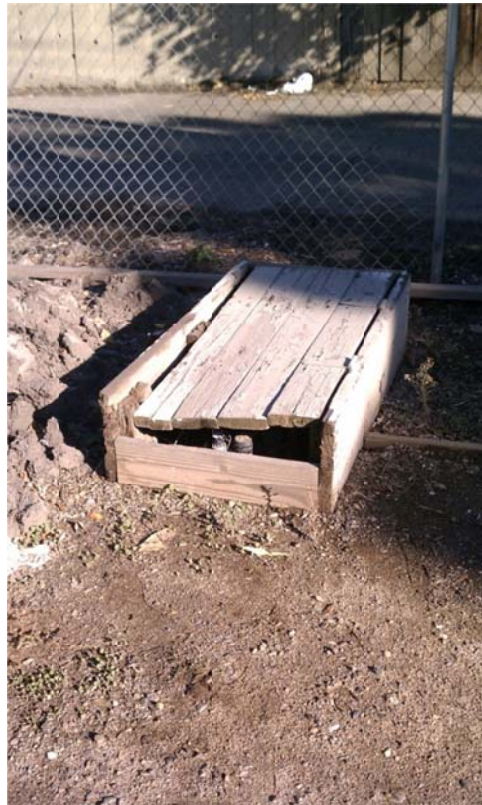
11

- Irrigation valves are located in an improper enclosure to the southeast side of the building. (Picture 11)
- Landscaping and irrigation is in fair to below average condition.
- Certain areas of the property, especially to the south, have bare dirt with no apparent function.
- Many of the trees on and around the property are overgrown and in need of trimming.

- Repair irrigation as needed for proper operation.
- Place irrigation controller in a proper irrigation below, preferably below ground to prevent damage from impact.
- Replace landscaping and trim trees as needed.

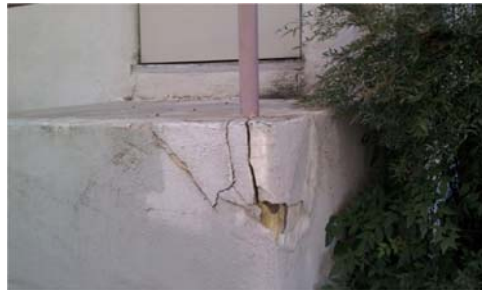
12

- Walkways and ramps around the building are in good condition and relatively free of trip hazards.
- Concrete landing on the north side of the building is cracked where the steel handrail enters the concrete. (Picture 12) This is a common occurrence when the handrail is either replaced or if the concrete surrounding the imbed is not properly reinforced. Over time this condition will compromise the strength and stability of the handrail. In addition, the concrete will continue to wear and fall away from the landing if not repaired.

- Repair the concrete landing by chipping away the concrete as much as possible around the imbed, removing any loose pieces. Roto-hammer multiple ½" holes directly into the concrete landing and install #3 rebar dowels and epoxy into place. Then form around the landing and pour a new concrete patch. Remove forms after about 7 days.

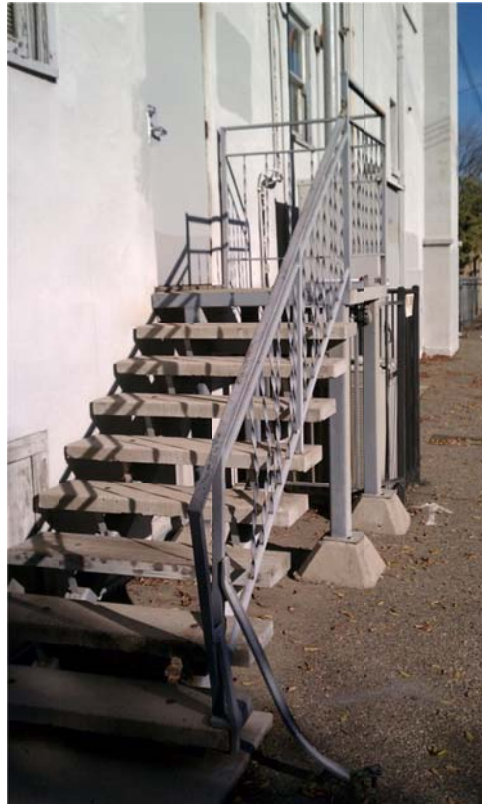
13

- Handrail at stairs on the south side of the building has failed. Previous attempts to reinforce this handrail have also failed (note diagonal steel kicker at the bottom of stairs no longer attached to the asphalt). (Picture 13) This condition creates a hazard for building users.
- All other handrails are in good condition. (other than the one noted in section 5 above)

- Replace handrail with new, properly supported handrail and paint to protect from weatherization.

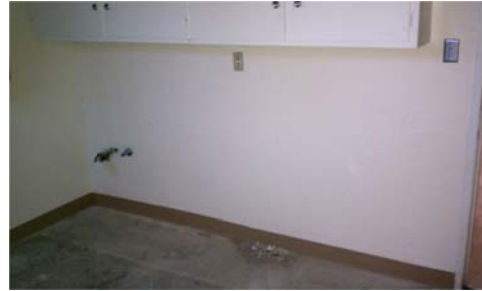
16B

- Cabinetry in the building varies in condition.
- Bathroom vanities are aged but in decent condition. They are protected with paint and should last quite a while. They are not ADA compliant as indicated in section 0.
- The basement kitchen cabinets are in a like-new condition. (Picture 16A)
- The 1st floor has one room that appears to be a former break room. The cabinets are no longer in this room and were removed for unknown reasons. (Picture 16B)

- Replace cabinets as needed in the break room.

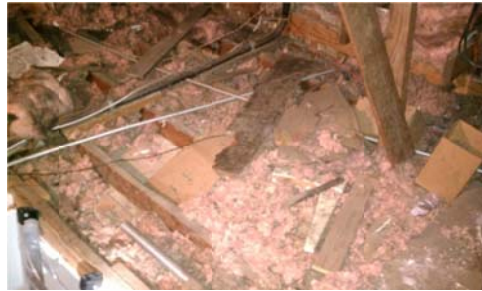
17

- Wall insulation, if existing, is unknown.
- Attic insulation is blown in cellulous insulation that appears to be 10-12 years old. The attic contained much debris that was compressing the insulation and causing it to loose insulating value. In addition, it appears the attic was accessed fairly often and subsequently the insulation had been moved and displaced. The inspector observed some areas of thicker insulation and some areas where insulation was sparse. (Picture 17)

- Injecting insulation into exterior walls would increase energy efficiency but most likely not provide the payback needed to constitute the cost.
- It is recommended the attic be cleaned of debris and re-insulated to maximize energy efficiency.
- It is also recommended that thermostat-controlled attic ventilation be installed to help moderate the temperature in the attic during warm months.

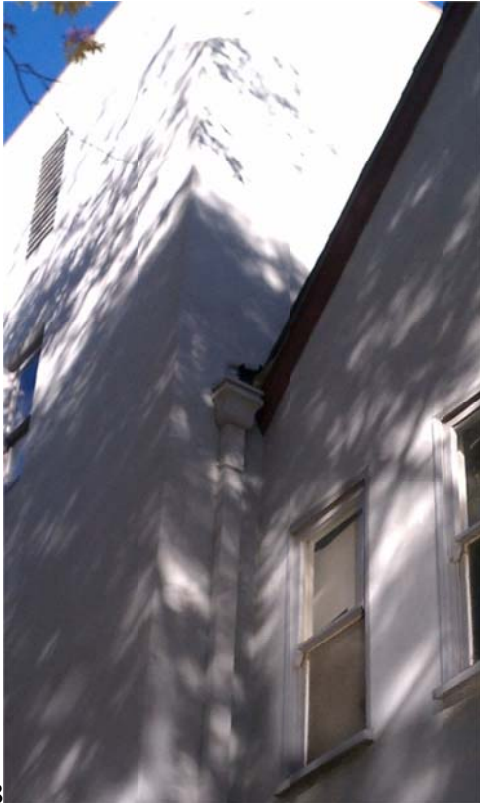
18

- The roof to wall connection along the west side of the building near the gutter downspout shows signs of water damage and potential water infiltration (Picture 18)

- Confirm ceiling damage is from old leaks and not existing leaks.
- Repair ceilings as needed to a like-new condition.
- Consider installing tar patches at the built-up roof to create proper drainage and eliminate puddling.
- Repair roof-to wall connection.

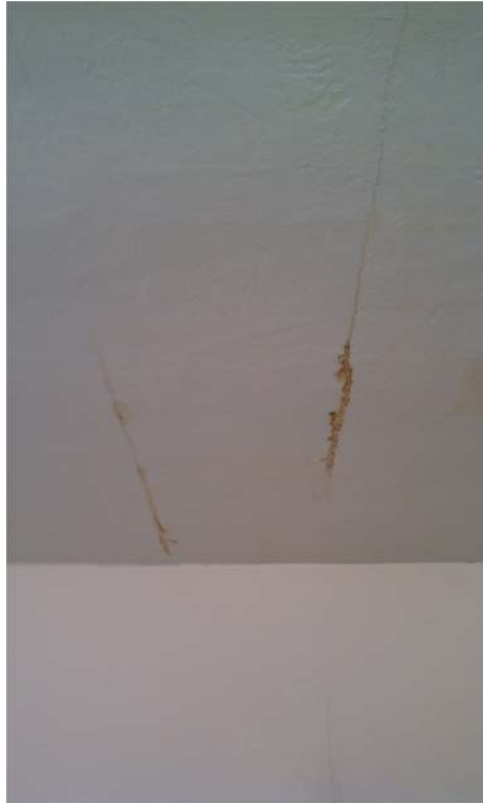
19

- There were multiple areas inside the building that showed signs of existing or previous roof leaks. These were indicated by staining of the ceiling (Picture 19) and bubbling of the ceiling paint (Picture 20).

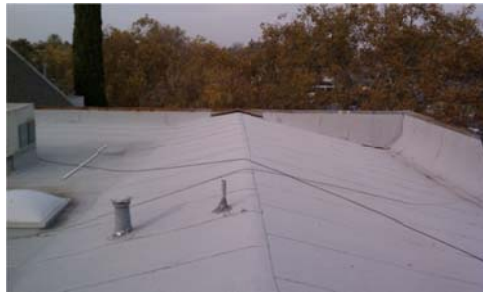
21

- The flat roof along the east side of the building is standard built-up roofing, and also in good condition. (Picture 21) The inspector noted a few areas of puddling near the edges of the roof well. (Picture 23) This indicated improper slope and eventually leads to roofing failure. The roof also had leaves and mud debris from lack of rood maintenance.(Picture 22)

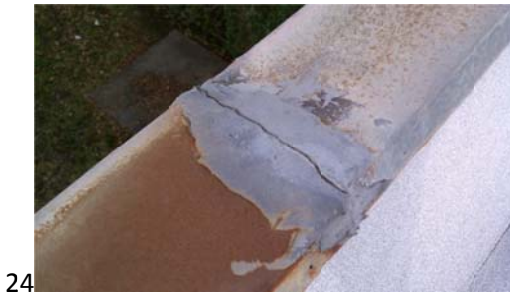
24

- The sheet metal parapet wall cap at the built-up roofing is in poor condition.
- The sheet metal itself is not protected from the elements with paint. (Pictures 24-25) This will cause pre-mature aging and eventual failure.
- The cap flashing joints are cracked and in need of maintenance. The mastic is no longer water-tight. This could allow water under the cap and into the exterior wall cavity.

- Remove rust and paint cap flashing to protect from the elements.
- Remove existing mastic at cap flashing joints and replace with new mastic.

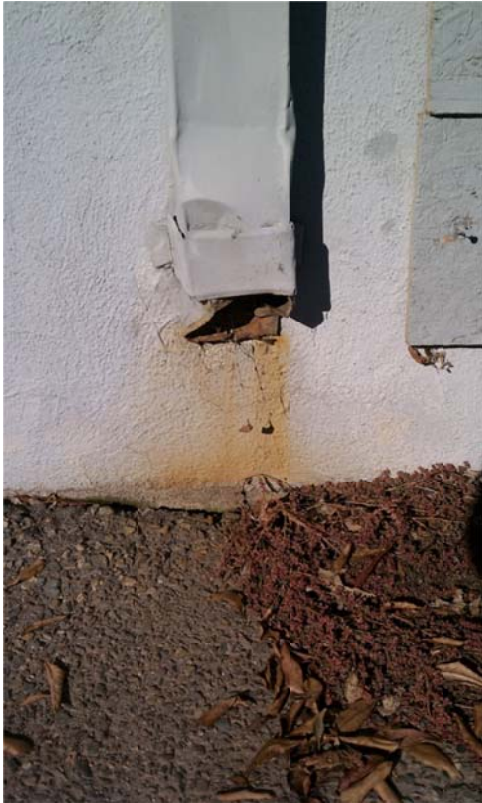
26

- Downspouts are disconnected from the wall along the south and east side of the building. (Picture 27)
- Downspout at parking lot at south side of building is broken at the bottom and allowing water to fall onto the building. (Picture 26)
- Gutters show sign of failure at east and north side of the building. Indicated by staining along walls, mildew growth at walls, etc. (Pictures 28-30)
- Gutters along north side of building have standing water indicating blockage of downspouts. This causes gutters to rust and fail and also allows water to get into building. (Picture 31)
- 2nd floor Choir Room shows sign of water damage along edges of room, adjacent to plugged gutters. (Pictures 32-22)

- The inspector recommends replacing all the gutters on the building.

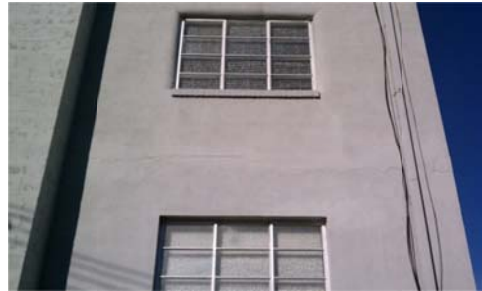
40

- Exterior plaster is in fair to poor condition.
- Some formerly arched windows have been replaced with rectangular single-hung windows. The plaster patch at these arches was poorly implemented, and there is significant cracking at the former edges of the arches. (Picture 41-42). This cracking can lead to water infiltration and eventual failure of the plaster patch.
- Second floor exterior door was closed off and patched in the past. This patch is also cracking, and could cause the same water damage and fall hazard as outlined above. (Picture 39)
- Various cracks, mostly horizontal, were noted in the plaster. This is a concrete where the cracks exceed 1/8" in width, which appears to be the case at the south side of the building. (Picture 40)

- The inspector recommends sealing all cracks with high-grade commercial caulking and then painting. Although the crack locations will still be visible, this will reduce the chance of water infiltration and prolong the life of the plaster.

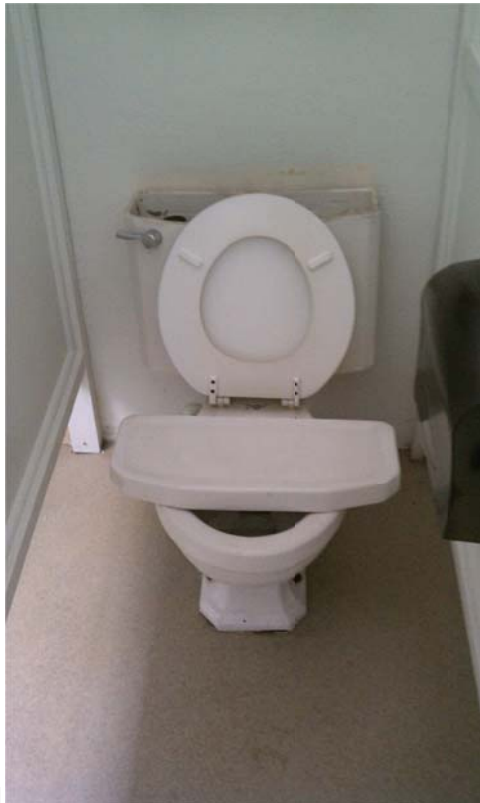
61

- Multiple toilets are not functioning properly. (Picture 61)
- In the basement kitchen, piping is exposed around a center support column. This poses a hazard and is visually obtrusive. (Picture 62)

- Make sure all toilets are sealed and set properly.
- Repair drinking fountains as needed.
- Repair all toilets as needed.
- Cover the exposed plumbing in the kitchen or cap and remove completely.

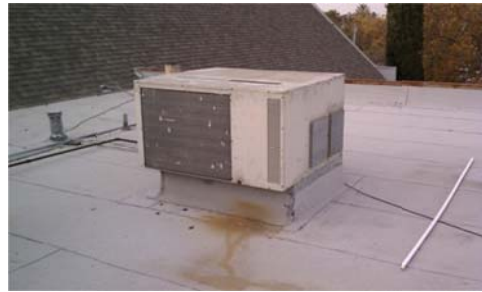
68

- The building is serviced by multiple split-system air conditioning units and some package units located on the flat roof portion of the building. (Picture 68)
- The furnace portions of these units are located in the basement, utility closets or on the roof, depending on the unit. (Picture 65)
- The condenser portion of these units is located on the building perimeter. (Picture 63)
- Two exterior condenser “cages” were empty. This indicates either these units were no longer needed, or perhaps they were removed do to vandalism. (Picture 64)
- A return air grille on the 1st floor is damaged. (Picture 66)
- Due to the age of the units and lack of maintenance, the ducts are likely dirty.
- The exhaust fans in the restrooms appear to be dirty. (Picture 67)
- The attic insulation is in good condition and appears to be well-insulated. (Picture 69)

- Trinity Renovation recommends a complete HVAC inspection with start-up and monitoring. This will provide extensive detail about the condition of the system and its remaining useful life.
- The inspector also recommends implementing an HVAC maintenance program should the building be acquired.
