Commercial Building Inspection

4213 Technology Drive

Modesto, CA

October 3, 2011

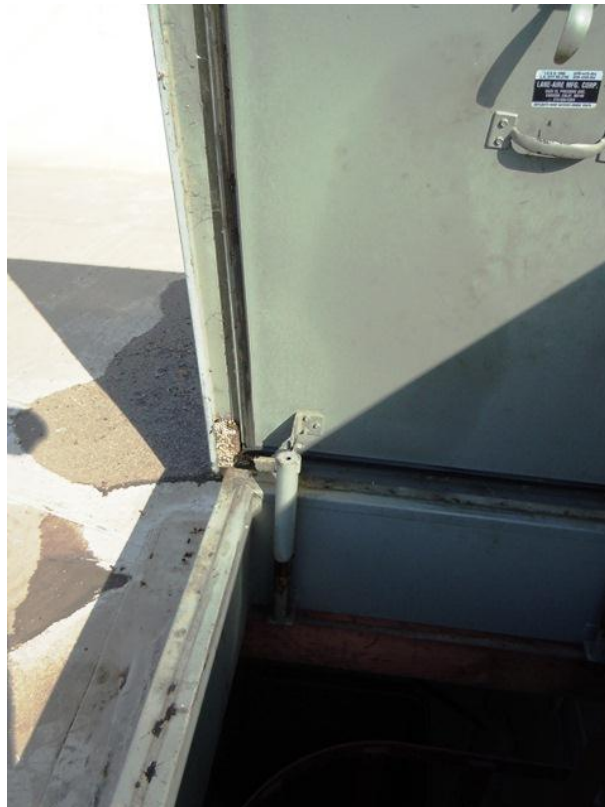
00-1

- A large wasp nest was found at the roof access ladder. (Pic 00-1)

- Recommend having a pest company treat for wasps.

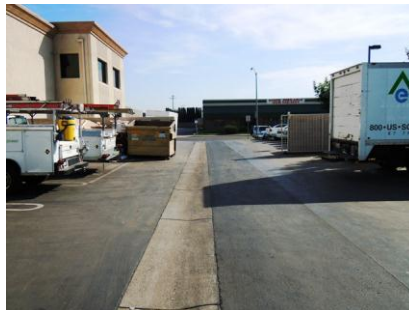
02-1

- In general, parking lot is in good serviceable condition.
- Parking lot appears to have been sealed since original construction and is in very good condition. (Pic 02-1)

- Seal the parking lot every 3-5 years to prevent premature wear, including filling of any cracks that may compromise the integrity of the paving.

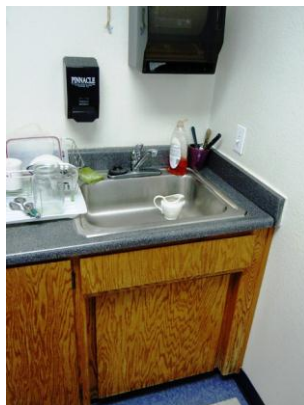
06-1

- Cabinetry in the building consists mostly of stain-grade cabinets and counters. (Pic 06-1)
- All cabinets and counters appear to be in like-new condition with no signs of past water damage.

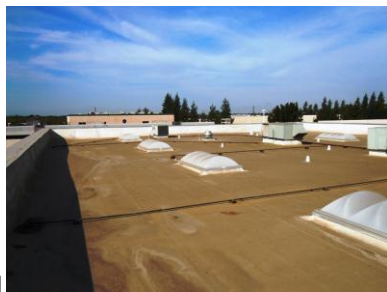
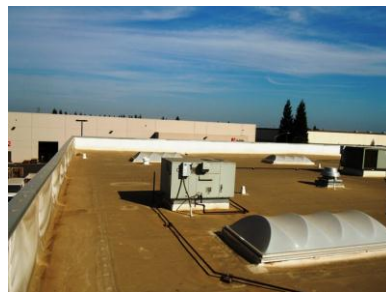
- The building features a single-ply roof system consisting of a PVC cap sheet mechanically fastened to the roof deck. (Pic 07-1, 07-3, 07-4)
- The parapet walls are also single-ply roofing. (07-5)
- Roof drains are spaced properly around the perimeter of the building and are tied into the underground storm drain system.
- Roof drains contain a standard “overflow” system that “daylights” approximately 22’ off the ground, facing towards the exterior of the building.
- Roof drain cavities contain a moderate amount of sediment and debris. (Pic 07-5)
- No signs that overflows have been active in the recent past.

- Clean roof drain cavities regularly to ensure proper operation.
- Monitor overflow drains during rain to ensure they remain inactive.

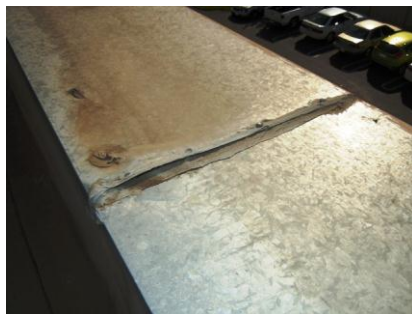
07-2

- Parapet caps are a standard-gauge sheet metal cap, sloping back toward the roof with drip edges on both sides. The cap is affixed using hex-head lag screws through the top of the cap and then sealed with vulcum caulking.
- The cap flashing joints are cracked in multiple locations and in need of maintenance. The mastic is no longer water-tight. This could allow water under the cap and into the exterior wall cavity. (Pic 07-2)

- Remove existing mastic at cap flashing joints and replace with new mastic as needed.

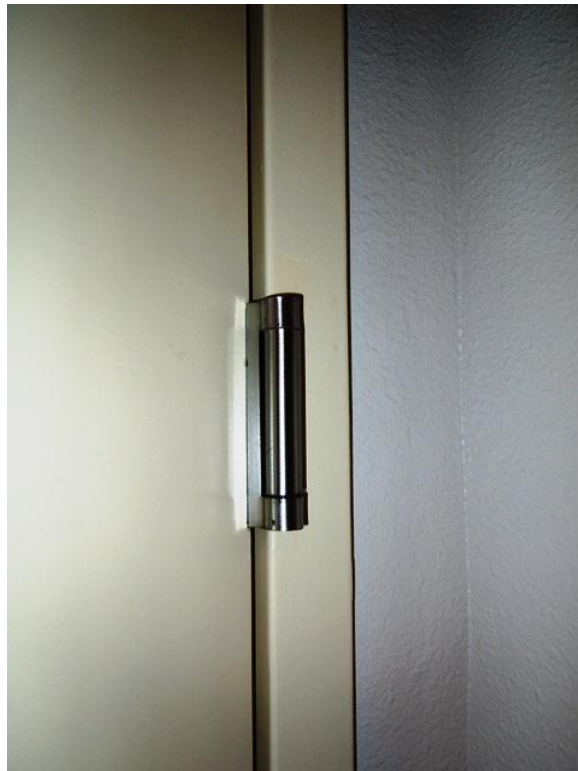
08-1

- Doors, frames and hardware are in very good condition and show signs of wear typical for the buildings age.
- 1st floor men's restroom self-closing hinge squeaks loudly when door closes. (Pic 08-1)

- Replace door hinge closer at men's restroom.

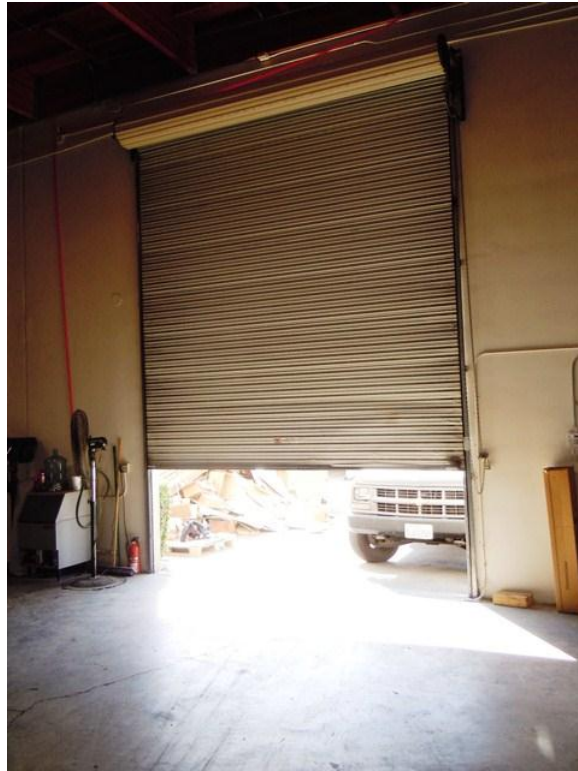
08-3

- Multiple roll-up doors are located on the building and are chain-operated coiling doors in very good condition. (Pic 08-3)

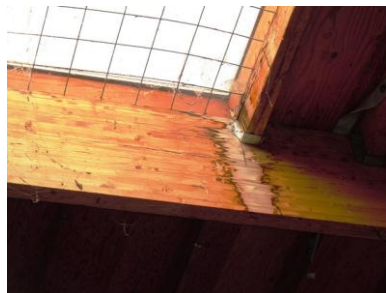
08-2

- Interior and exterior windows are aluminum storefront with single and dual-pane glass.
- Skylights in warehouse show signs of current or past leakage. (Pic 08-2)

- Recommend water testing the skylights to identify potential leaks and repair.

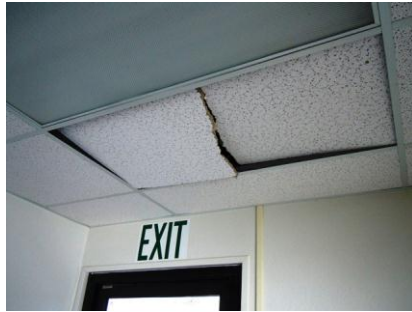
09-1

- T-bar ceiling throughout is in very good condition.
- In 1st floor hallway new exit door, there is a damaged t-bar tile. (Pic 09-1)

- Replace damaged ceiling tiles as needed.

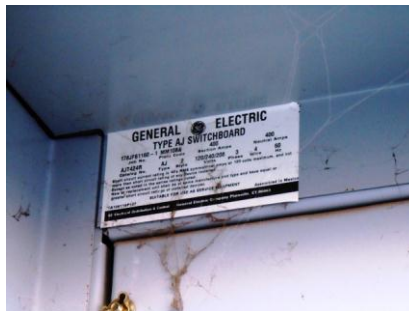
16-1

- Transformer serving multiple buildings is located to the northwest of the building.
- Electrical switch gear is located on the east side of the building and accessed from the outside.
- Switchgear is a 400 Amp service. (Pic 16-1)
- Telephone and cable MPOE is located inside the building.
- Interior lighting is fluorescent strip lighting in the warehouse and 2x4 and 2x2 tropher lights in t-bar grid areas.
- Lighting is energy-efficient A/B switching with occupant sensors in most rooms.
