Commercial Building Inspection

918 Sierra Drive

Modesto, CA

December 8, 2010

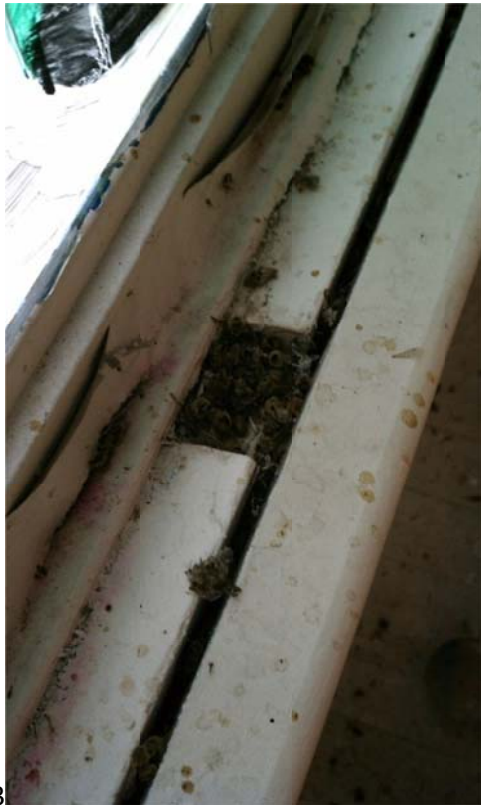
- Two sources of bees were noted at the intersection of the roof line to the building along the west side of the property.
- Dead bees were found in large quantity behind the baptismal. (Picture 3)
- Rodent traps were found around the property, specifically in the 1st and 2nd floor office areas. (Picture 4)

- Conduct professional pest inspection and follow recommendations within.

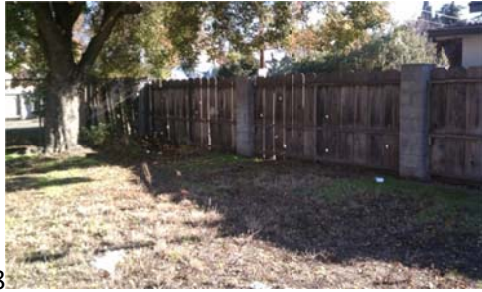
8

- Chain-link fencing along the east and west side of the property is in good condition.
- Wood fencing spanning between masonry piers on the south side of the property is in various states of disrepair. (Pictures 8-10)
- Many dogs were freely moving between neighboring property and the alley and the inspected property during each site visit.

- The inspector strongly recommends re-building southern fence, specifically for the safety of those who will use the inspected property upon purchase.
- Masonry piers are in good condition and can be used as the primary support for the re-built fence.

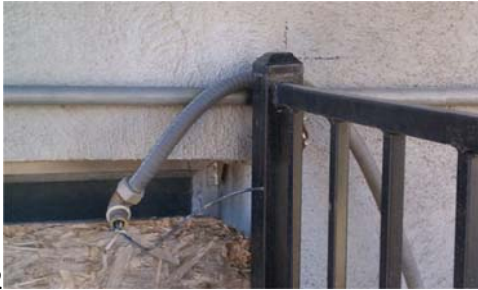
72

- The building appears to have a combination of old and new wiring. Some wiring is in the wall cavity or in the attic and others is surface mounted in conduit. Our experience from buildings of this vintage is the wiring is a combination of aluminum and copper.
- Multiple light fixtures are not functioning due to expired lamps (bulbs) or broken ballasts. (Pictures 70 & 74)
- On the exterior of the building, south side, exposed wires should be capped and pushed into the wall cavity.
- At former condenser location on the southeast side of the building, wires are exposed and need to be capped. (Picture 72)
- Surface mounted conduit in the basement is loose. (Picture 73)

- Trinity Renovation recommends an inspection by a licensed electrical contractor to review in further detail the entire electrical system, and also to identify any potential hazards.
- Recommend repairing all lighting not functioning properly.
- Recommend capping and/or removing all exposed wires.
- Secure all surface-mounted conduits to prevent further damage.
